PROGRESS REPORT #15

ENGINEERING PROGRAM FOR THE DEVELOPMENT

OF A LIGHTWEIGHT ANTI-TANK ROCKET

NOVEMBER 1958

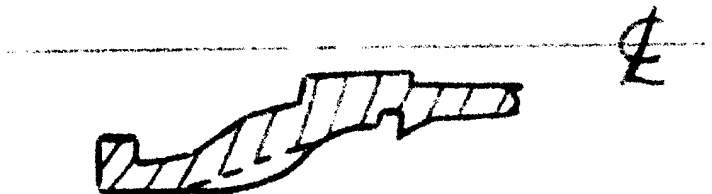
In trying to evaluate the difficulties encountered with the igniters, it was found that only a very small number of igniters had been fired at the cold temperatures. Igniter push-out tests at cold temperature were immediately conducted. (See tabulation in appendix) This was done by means of placing igniters into a cold box at the temperature of -20° in the laboratory and pushing them through using the standard igniter fixture. A tabulation of the results of these tests is shown in the appendix. It was found that by machining a small angle off the igniter cap a decrease in push-through pressure could be obtained. This modification was put into effect on 10 igniters, and another ignition and accuracy test was conducted on 14 November. The modification to the igniter is shown in the following sketch:

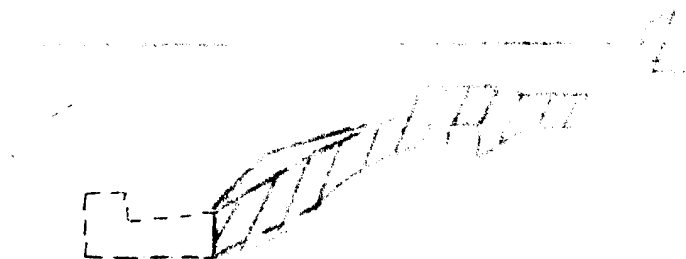
In evaluating the results of this test, it appears that the modification to the igniter has produced some improvement. However, **it was** insufficient. The ridge on the inside of the powder cup in the igniter (see following sketch) was then removed and the method of wrapping polyethylene over the igniter reverted to. Another accuracy test, this time at 50 meters, was conducted, and the following is a tabulation of the results:

It is felt that the breaking off of part of the igniter was due to a stress concentration caused by the ridge inside the cup. Drawing Nos C8120-9,10

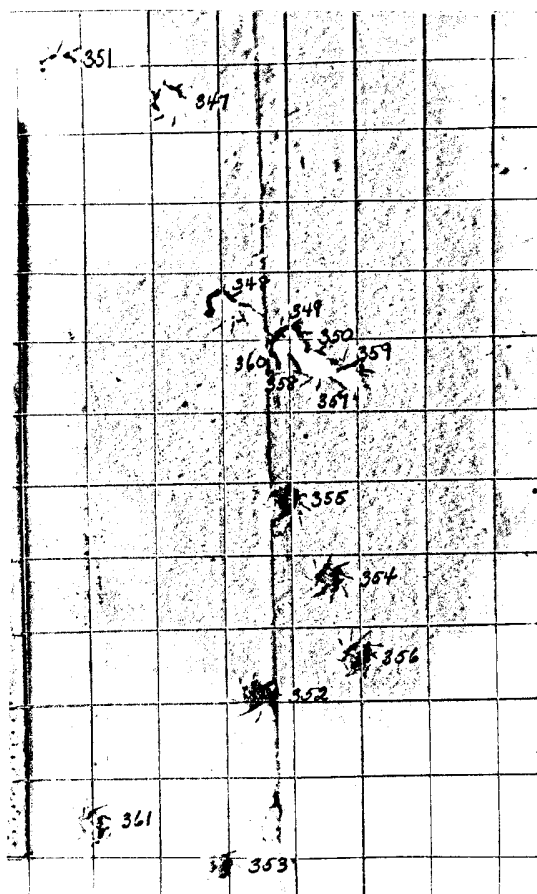
Photograph No. 141 is enclosed in the appendix. This photograph has a 6" grid super-imposed to give a clear picture of the target configuration which can be used for evaluation of the accuracy of the round. The spread in this group may be somewhat excessive for two reasons:

1. Faulty propellant in Round No. 248 which was picked out of an old unmachined batch by mistake.
2. The igniter parts which were to be found in the cold motors.

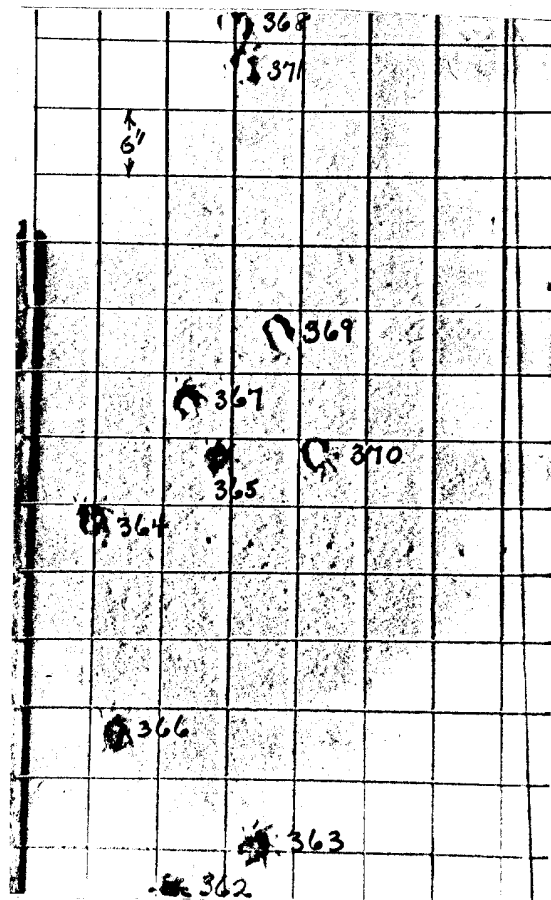
Photograph No. 142 shows the target obtained in this test.

This was the first test when the 50-meter target was available. As can be seen from the photograph, the group is extremely satisfactory. The igniter problem appears to have been solved. One more similar test will be conducted in December for further confirmation.

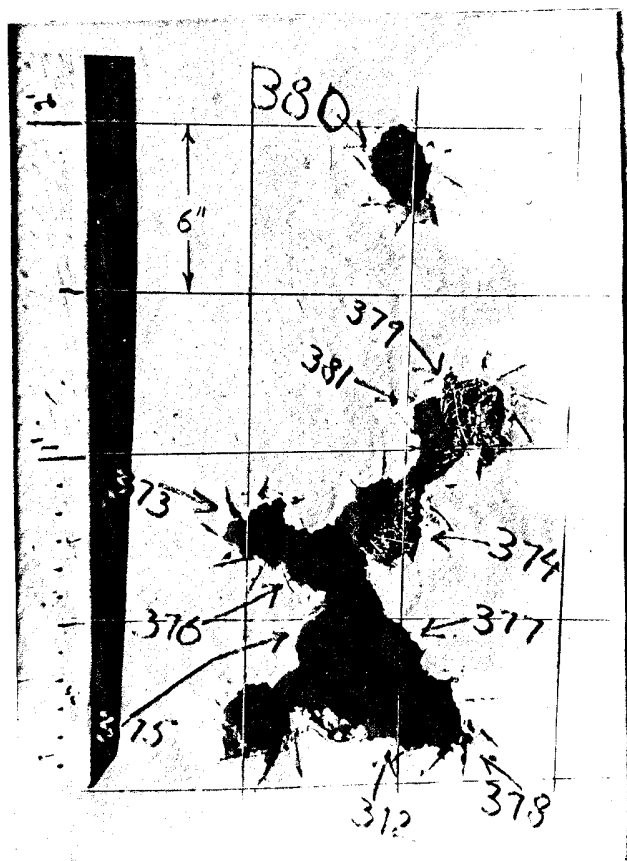
Photograph No. 143

Round Nos. 373 and 387 failed to set back. Round Nos. 375, 382, and 389 failed to set off the detonator and needed an additional impact consisting of a drop of up to 6" in order to release the firing pin and initiate the detonator.

Round No. 383 functioned completely. However, the firing pin had not pierced the detonator, and the fuze initiated its detonator when dropped from a height of 24".

Round No. 385 failed to arm.

These tests show four distinct problems:

1. Graze sensitivity
2. Setting back of the triggering components.
3. Arming.
4. Initiating the detonator.

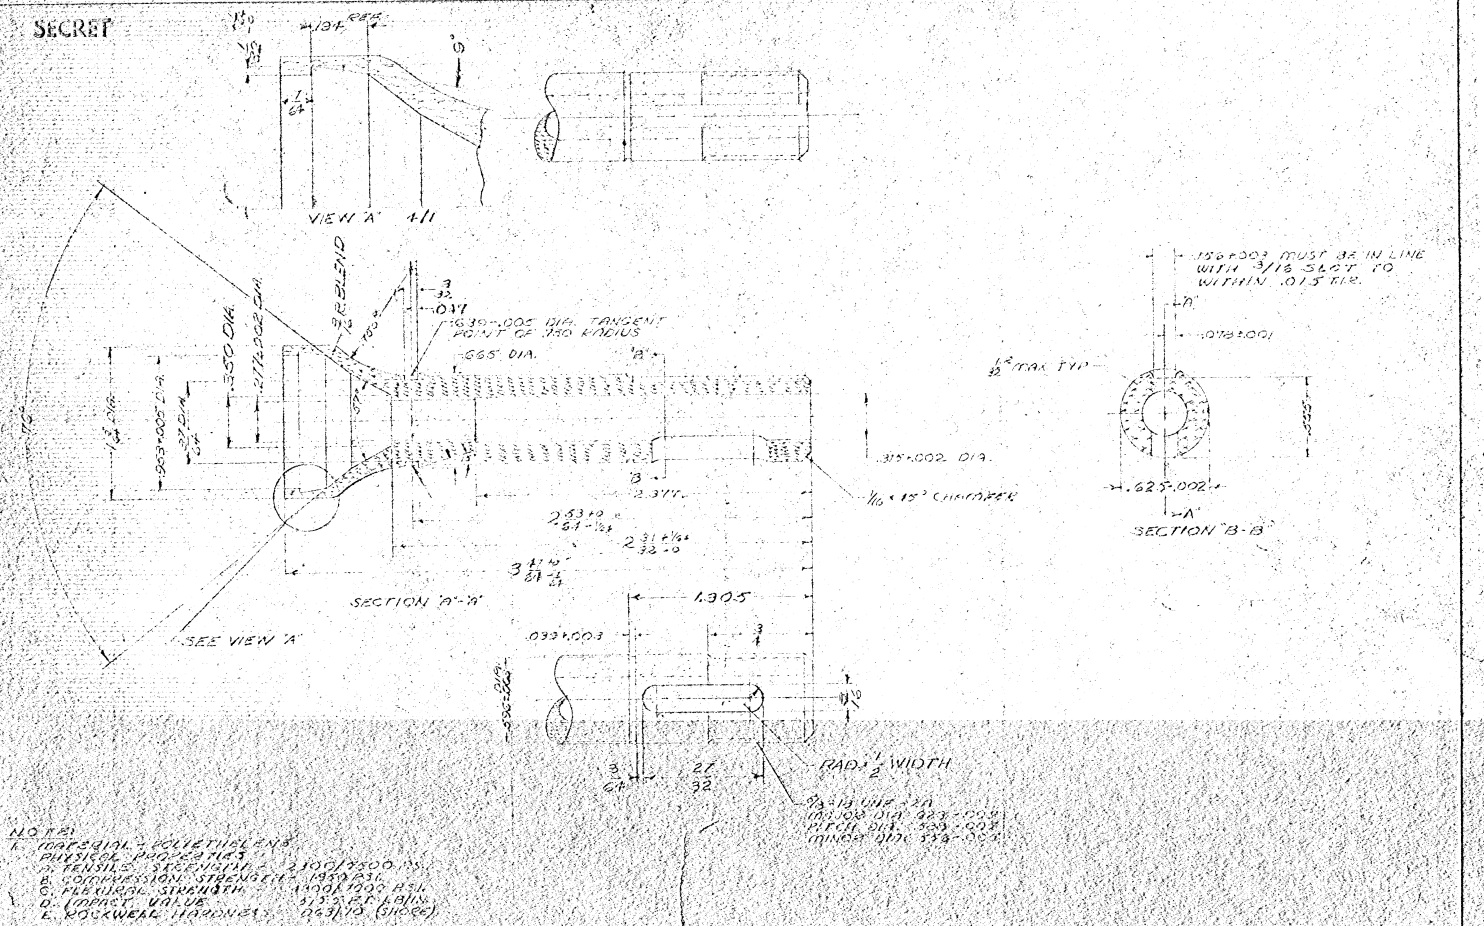
in the appendix shows the old and the new configuration in the igniter cup.
